Volume 8

Asbestos-Containing Material Re-inspection For Building 36 Charleston Naval Shipyard Charleston, South Carolina

Contract No. N2467-96-D-0998 Delivery Order No. 0013

BAT Associates, Inc. 5151 Brook Hollow Parkway Suite 250 Norcross, Georgia 30071 (770) 242-3908

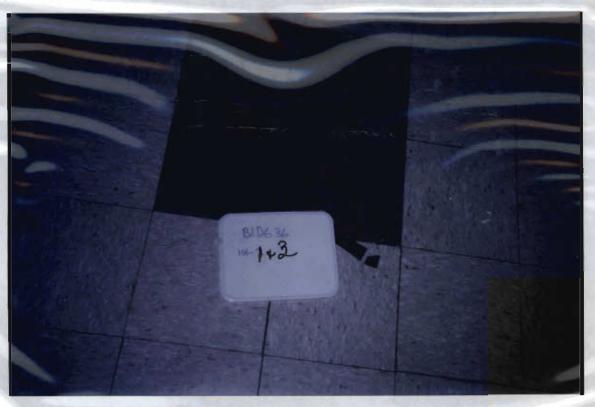
Floor Tile, 9" x 9" black w/ black mastic, HA # 1

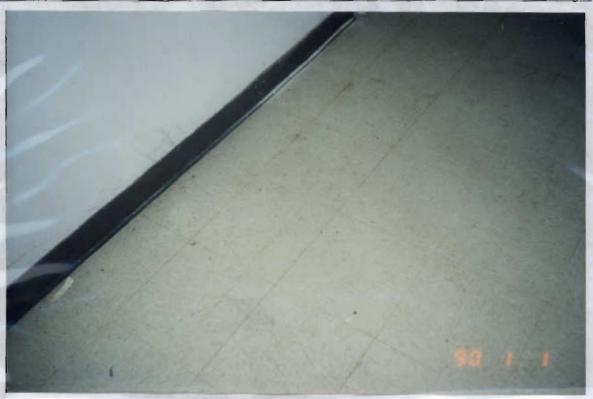
Floor Tile, 12" x 12" off-white with brown streaks w/ black mastic, HA # 3

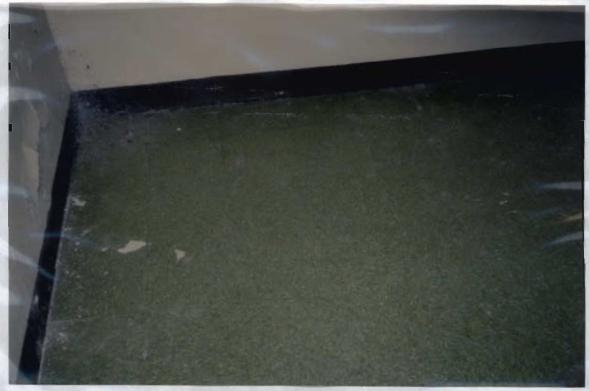
Floor Tile, 12" x 12" beige with gray speckles w/ black mastic, HA # 4

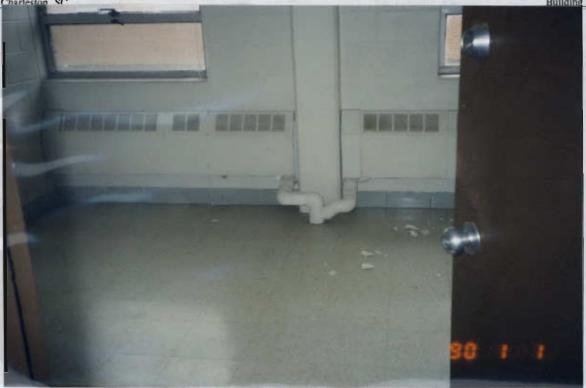
Floor Tile, 12" x 12" lime green with white streaks w/ black mastic, HA # 5
